## Early Warning System for karst groundwater contamination

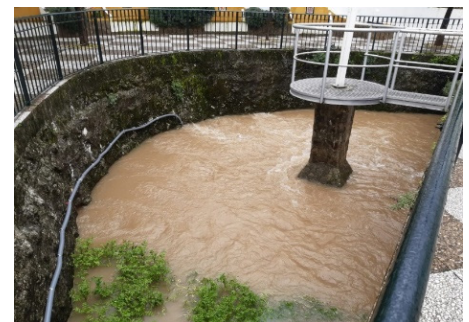
Figure 1: Algarrobal spring at Ubrique test site during a contamination event with high turbidity.

During KARMA period, several flooding events with associated turbidity were registered at the three test sites. Maximum turbidity records varied between  $\approx 15$  NTU at Lez spring (France) and  $\approx 340$  NTU at Algarrobal spring (Ubrique test site, Spain, Fig. 1). The maximum activity of *E. coli* measured during KARMA period apparently showed proportional values with turbidity between test sites:  $\approx 480$  CFU/100mL

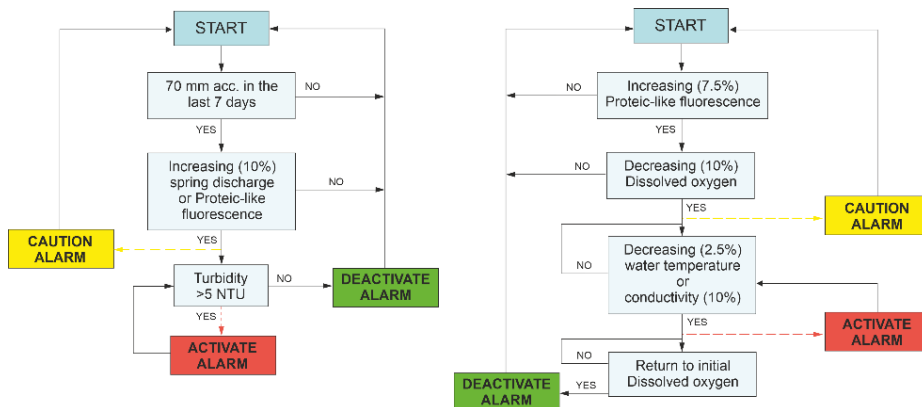
Figure 2: Architecture of Early-Warning workflows developed for Ubrique and Lez karst systems.

the three test sites: the identification of (1) potential hazardous substances for human health and (2) "Early Warning" parameters. More refined protocols were developed facing the implementation of individual EWS (France and Spain test sites) with the definition of the EWS workflow (Fig. 2) and specific thresholds that activate the warning alerts adapted to hydrogeological features, contamination type and operational characteristics of the drinking water distribution system.
